# **Windows Unified Driver User Guide**

**VeriFone, Inc.**, <http://www.verifone.com>

## Revision 0.1.3

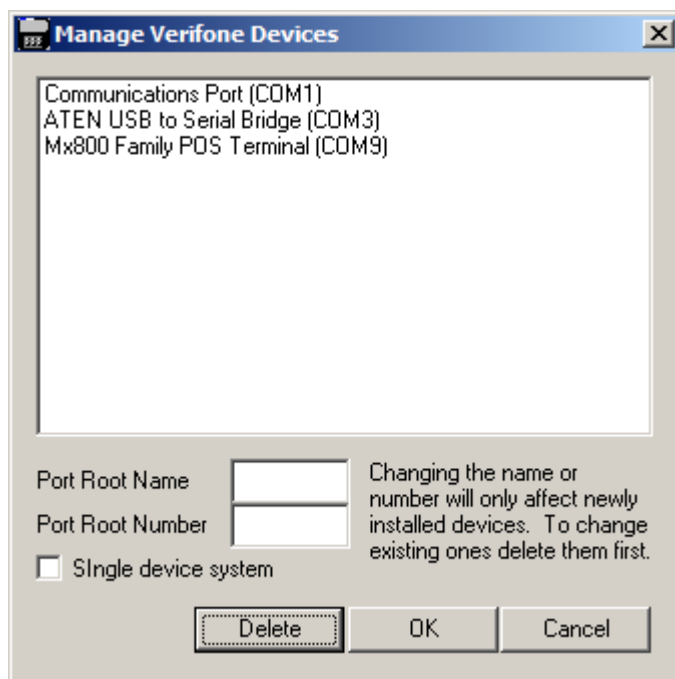
Run Verifone Device Manager

This shows all the communication ports on the machine, whether the devices are connected or not.

Selecting one of them, and clicking Delete, removes that device from the system. If it is a Verifone device the number it is using is liberated and will be reused by any new devices installed.
